GENERAL BUILDING INSPECTION FOR
1102 205th Avenue NE, Sammamish WA 98074
FOR THE EXCLUSIVE USE OF Matthijs and Sandra Hoekstra

Tuesday, July 14, 2015, 10:00 AM

cover letter, 28 page report

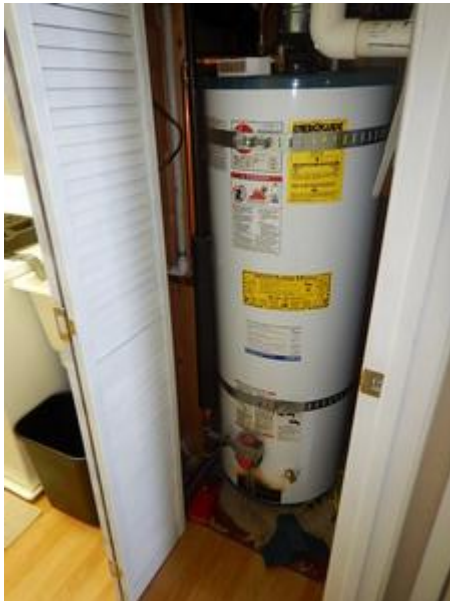
The visible plumbing system has copper water supply lines, ABS plastic drain-waste-vent lines, and a 40,000 BTU gas-fired water heater of 50 gallon capacity. **The water heater is thirteen years old and is likely nearing the end of its useful life; typical life expectancy of gas-fired water heaters is said to be ten to twelve years. The inner flame roll-out shield is missing, which is why there are scorch marks on the front of the unit.**

Rheem gas-fired water heater

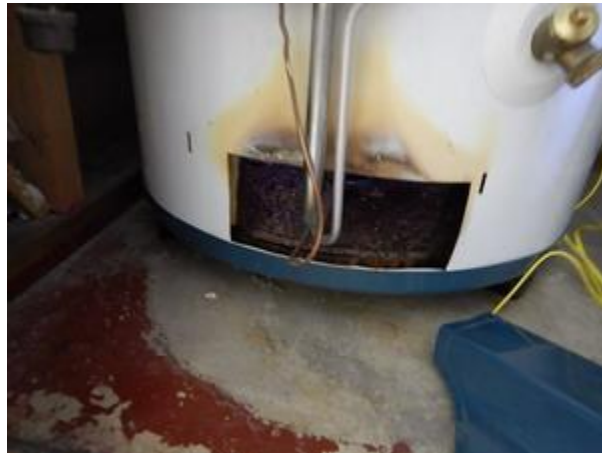
scorching at burner compartment opening

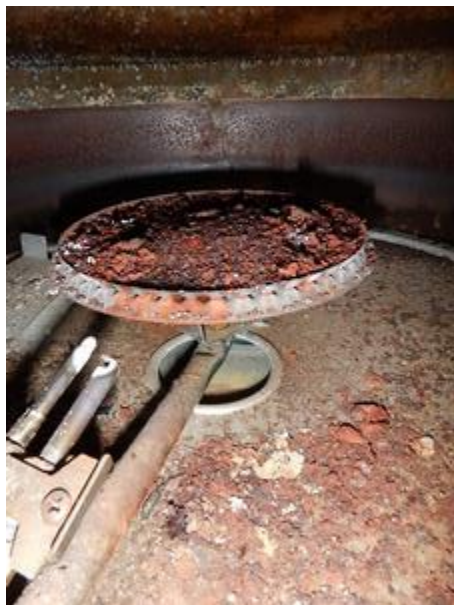
21 corroded turbulator debris on burner
22

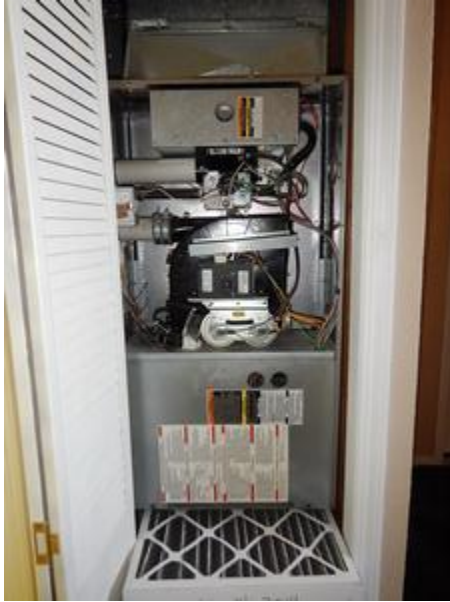
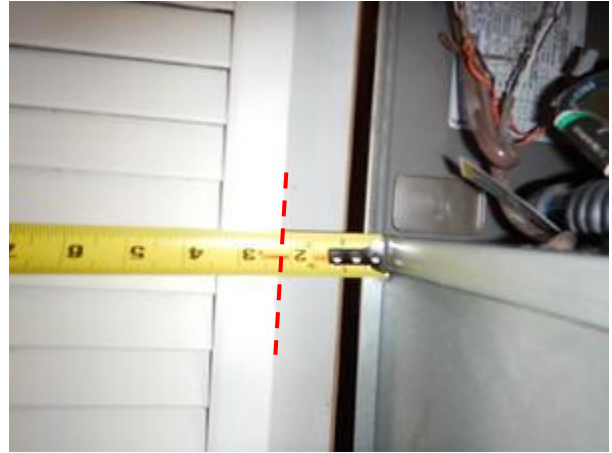
Bryant/Carrier induced-draft gas-fired furnace 3 inch clearance to combustibles not achieved

3
4 **Due to the absence of recent or regular servicing, a licensed HVAC contractor**
5 **should be retained to further evaluate this system and service and/or make any necessary**
6 **corrections.**

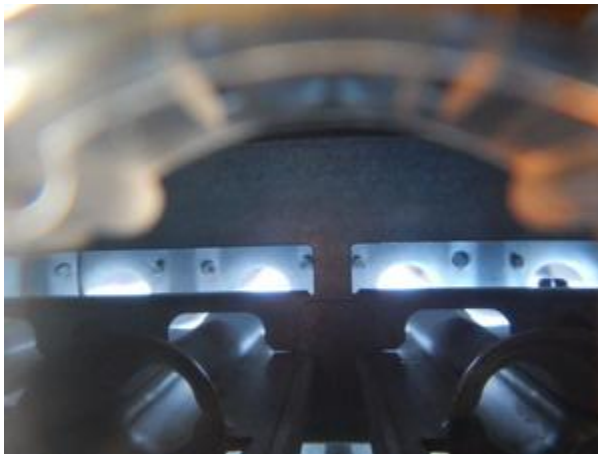
Removal of the furnace panel cover revealed a strong blue flame and good flame characteristics. Due to the design, none of the heat exchanger is accessible to inspection without dismantling the furnace. Radial play in the blower shaft and bearings is not excessive. The blower functions properly and quietly. The extended media filter is relatively clean.

strong, blue flame characteristics

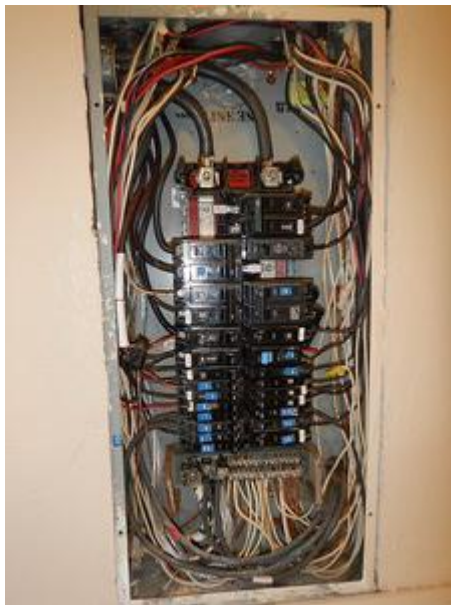
10
11 The 120-240 volt overhead electrical service is connected to the original General Electric
12 split-bus 200 amp circuit breaker panel in the northwest corner of the basement. **Many of the**
13 **breakers are not properly labeled as to circuits served; such labeling can be critical in an**
14 **emergency. Corrective action is recommended.** Removal of the service panels cover reveals
15 aluminum 4/0 service entrance cable (from meter to panel), copper branch wiring (from panel to
16 house), multi-strand aluminum wiring for the range, hot tub, and “mystery” 50 amp circuit, and a
17 60 amp sub-main disconnect for the household circuits. The aluminum conductor ends are coated
18 with an antioxidant paste, which helps to ensure a proper connection between the wires and the
19 contacts. The system is grounded to a driven ground stake. **The purpose of the large but**
20 **unlabeled 50 amp circuit breaker is unknown (there is another one labeled “hot tub”); a**

21 **written dialogue with the seller on this point is recommended. None of the requisite electrical**
22 **permits were in place for the changes in the electrical systems; permits are required for all**
23 **electrical work (e.g., remodels, hot tub, etc.); a conversation with the seller on this point is**
24 **recommended.**

26 General Electric split-bus circuit breaker panel
27

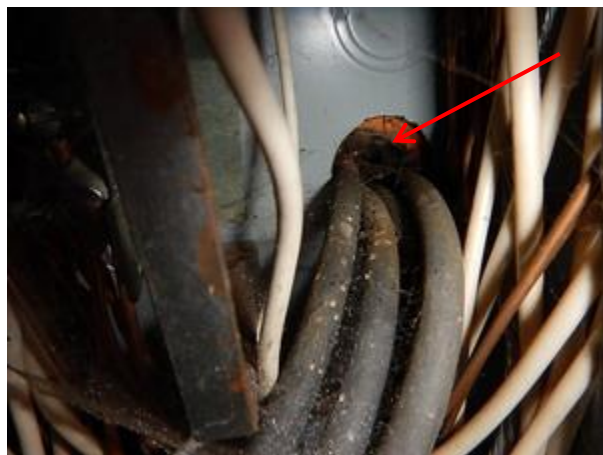
- romex connectors have not been used to clamp the hot tub conductors to the panel side;
- some unused conductors are not properly terminated inside the circuit breaker panel;
- multiple double taps have been utilized so that one breaker improperly provides power to multiple circuits in the main panel and the garage sub-panel.

romex connector (bushing) required here

Due to the defects noted, a licensed electrician should be retained to survey this system and make the necessary corrections.

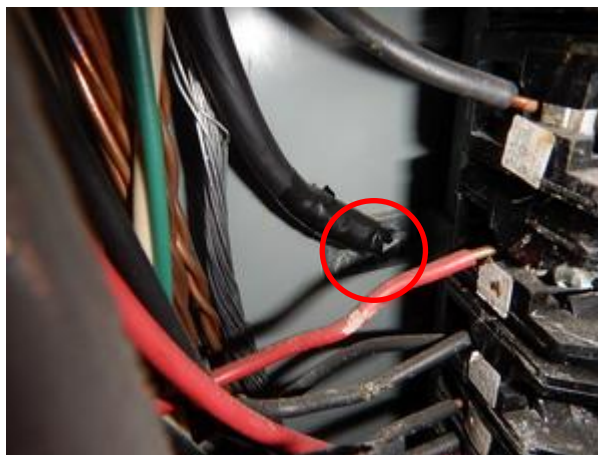
improperly terminated conductor

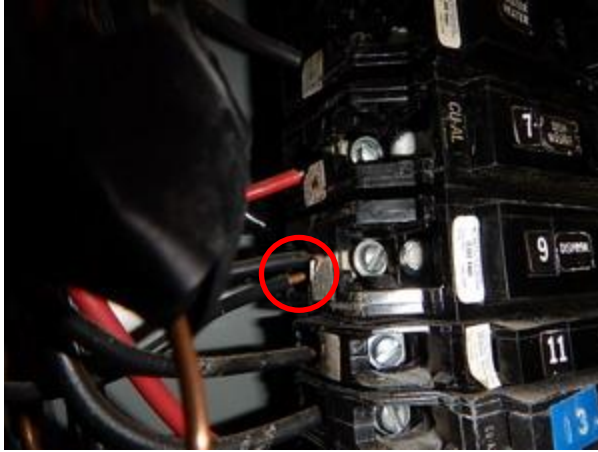
double tap in main panel

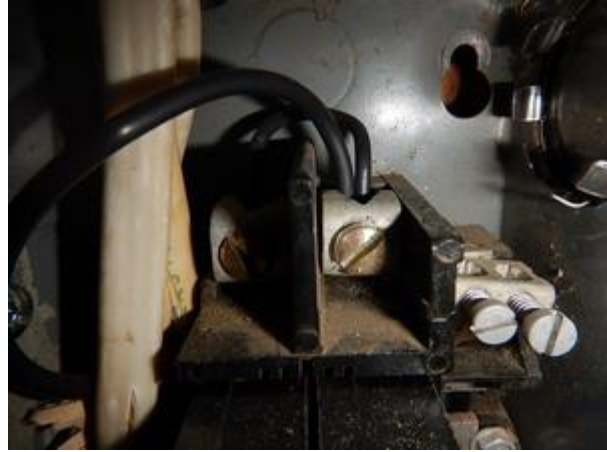
double tap in garage sub-panel

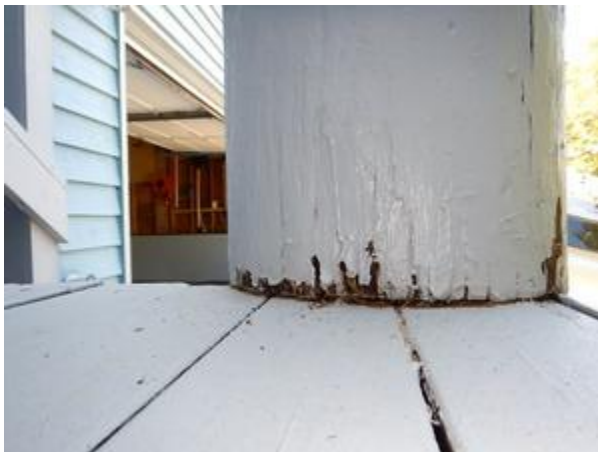
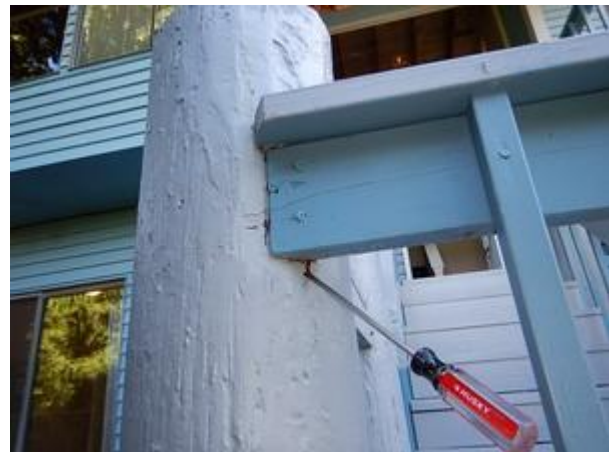
No significant defects were noted in the tight knot cedar lap siding. The door and window sills are in serviceable condition. The exterior hose bibs are functional but have not been properly attached to the structure. If not properly secured, the torque from turning the handle is transferred to the copper piping and solder joints. The eave areas are in serviceable condition with numerous vents to the attic. **All of the peeler poles used on then home are in varying stages of decay.** The amount of rot in each pole could not be determined due to the rubberized paint used, but it is likely extensive. Peelers were popular back in the day but because they were not treated, they were highly susceptible to decay and bug infestation. Budgeting to replace the peelers with pressure-treated 6x6 (or 4x4) framing in the foreseeable future would be prudent.

decay noted in all of the peeler poles

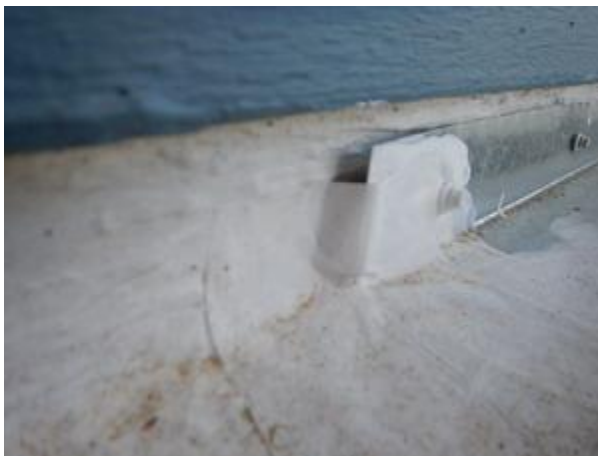
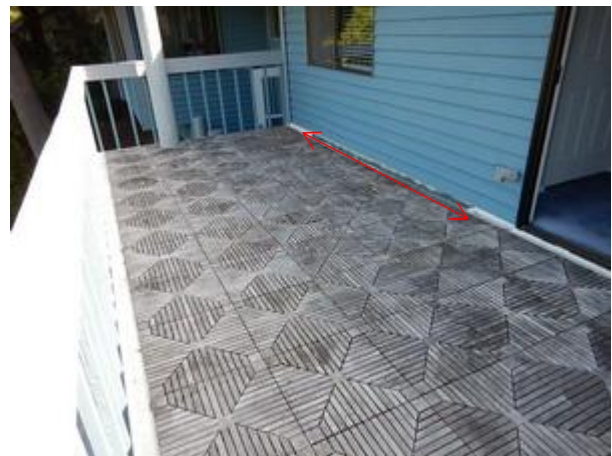
1 All of the deck attachments require attention. The deck off the master bedroom also
2 serves as the roof for part of the garage. Roofdecks in the rainy Puget Sound region have
3 historically been somewhat more troublesome and/or maintenance intensive than
4 conventional decks for the obvious reasons. The deck coating appears to be a fluid-applied
5 elastomeric coating under the wood block pads. The construction is unusual, in that the deck
6 slopes back towards the building, where a single screened scupper handles the drainage. It
7 will be critical to keep the scupper clean and smooth flowing, or moisture intrusion into the
8 building envelope may occur. The deck transition to the home requires immediate attention.
9 An extra piece of flashing has been inexpertly installed, indicating recent problems. The
10 flashing has not been installed in a weathertight manner. Immediate corrective action by a

11 qualified waterproofing deck contractor is recommended. Water stains in the garage ceiling
12 indicate that past moisture intrusion has been an issue, but no decay was located.
13

14
15 amateur flashing repair not watertight
16

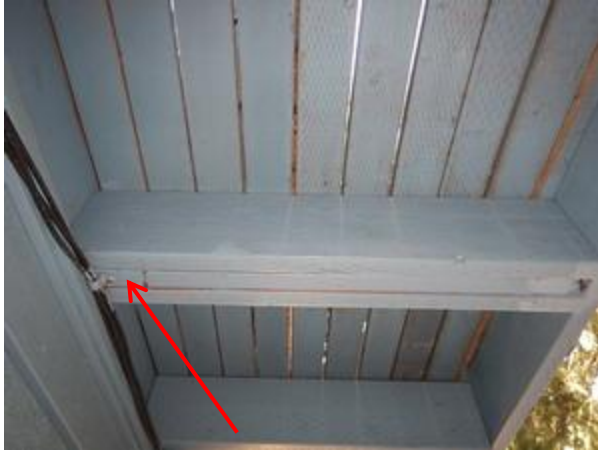
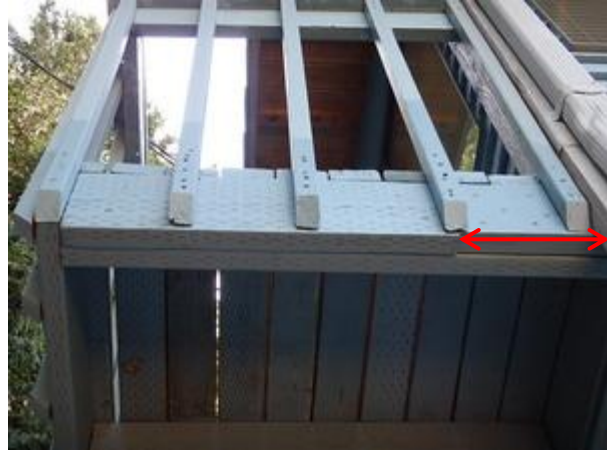
17 The deck on the north side of the home also requires attention. The deck was
18 originally constructed with untreated cantilevered framing and decking. The number of
19 components replaced with pressure-treated wood indicates that rot did become an issue.
20 Some of the framing repairs are questionable and it is evident that the strength of the
21 original framing has been compromised. At a minimum, a post should be placed in the
22 northwest corner, but long term repairs will require total replacement of the original
23 members (extend into the building envelope) or an engineered post and beam repair.
24

original supported joists carrying replacement components

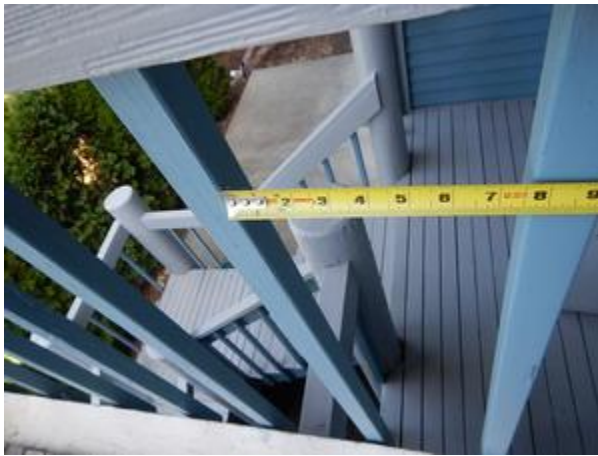
The baluster spacing on both decks exceeds that allowed by current building regulations; any opening must be such that a four inch sphere cannot pass through [IRC 312.2].

7+ inch baluster spacing

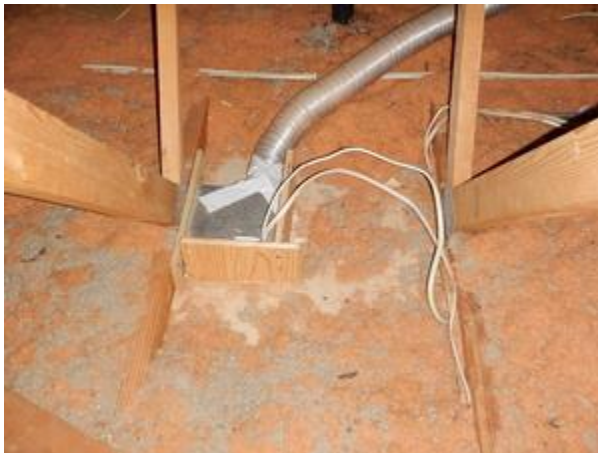
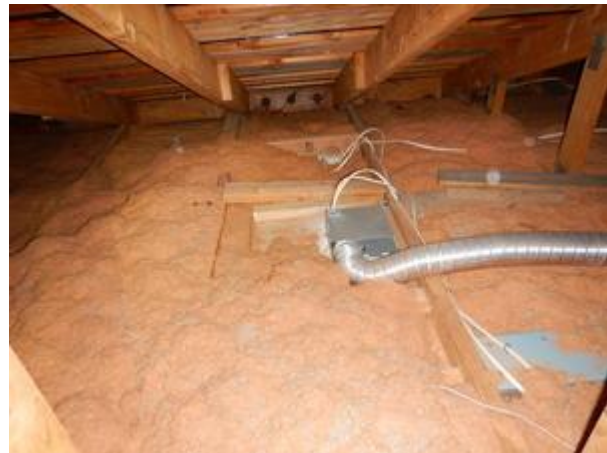
The attic has three to four inches of blown-in cellulose insulation providing an insulating factor of approximately R-11. **The insulation has been compressed and/or disturbed in some areas, probably by workman traffic, reducing the R-value, so the insulation should be redistributed and/or “fluffed” to regain the proper insulation value.** New homes require R-49 or more, so there is considerable room here for improvement if the heating bills warrant. It should be noted that the existence of attic insulation hampers and in many cases prevents a visual inspection of the framing members. The vertical planes are insulated with fiberglass batt insulation.

disturbed/missing insulation at retrofit fans

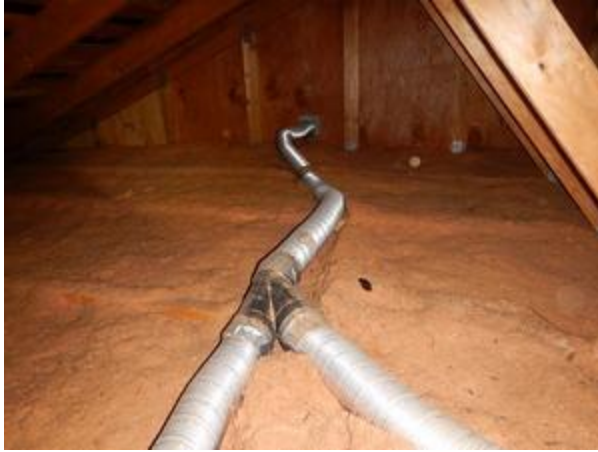
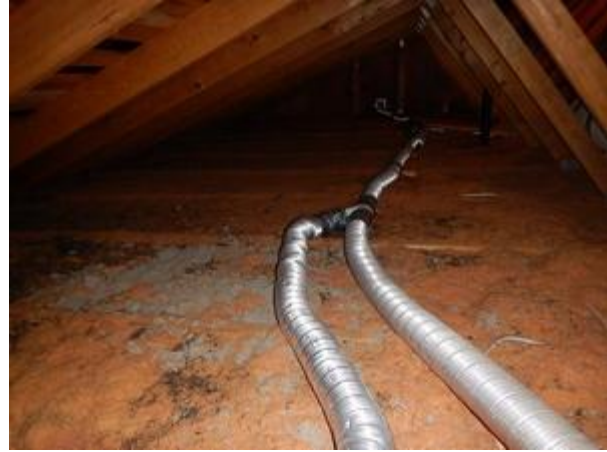
Ventilation is minimal but appears to be adequate, consisting of one gable vent, and numerous eave vents. The air is dry and there are no signs of condensation. The bathroom fans are ducted to the outside via a gable wall vent, as is the kitchen fan duct. **All three bathroom fans are ducted to the exterior using the same duct; occasionally this can lead the fans drafting into the other bathrooms. Replacement with separate insulated ducts is recommended.**

all three bathroom fans utilize the

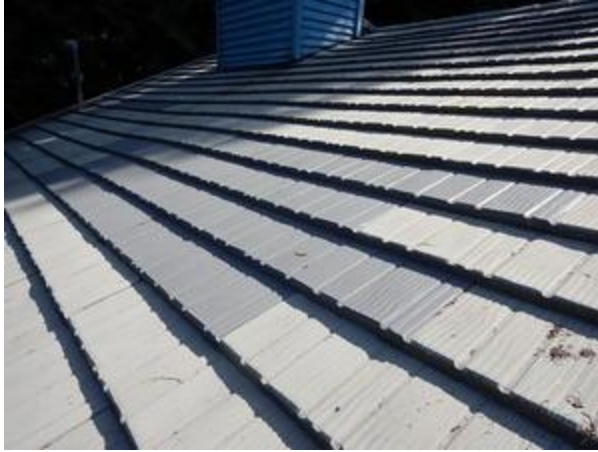
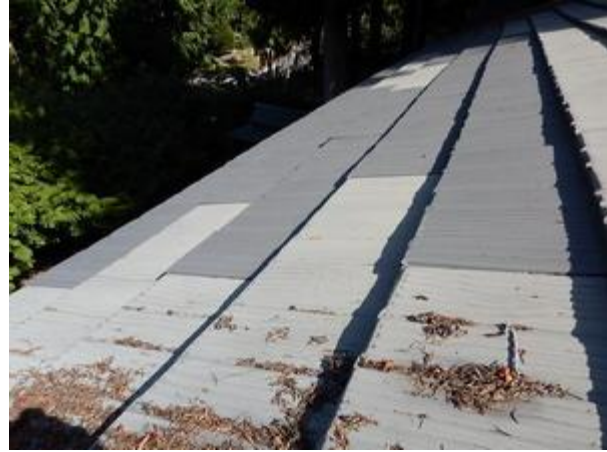
The visible roof consists of one tier of imitation tile metal shingles. Due to the delicate and slippery nature of this type of roofing material, it could not be walked safely. The roof was therefore inspected at random points from a ladder. Although most significant defects will usually be visible, some defects may go undetected when the roof cannot be walked. *There may be deficiencies that would have a negative effect on the value of this home.* No significant defects were noted in the roofing material or vertical plane or chimney flashing*. This type of roofing material is frequently installed over an older roof, typically a cedar shake or shingle roof. The skip sheathing in the roof would be consistent with an original shake or shingle roof, but there is no visible evidence of an older roof. A written dialogue with the seller on this point and collateral warranty issues is recommended. Numerous shingles were noted that have been replaced, and several spare shingles were noted in the attic; a conversation with the seller on this point is recommended.

numerous shingles have been replaced

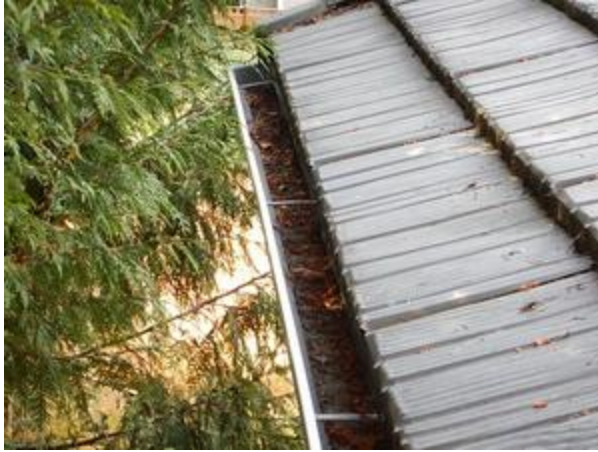
No significant defects were noted in the aluminum gutters **but some of the gutters are partially clogged with organic debris and should be cleaned. As is typical, some of the gutters have a reversed slope away from the drainage downspouts, and will collect water.** Gutters are an integral part of the roof system and in order to properly maintain a roof, the gutters must be kept free flowing.

organic debris in gutters

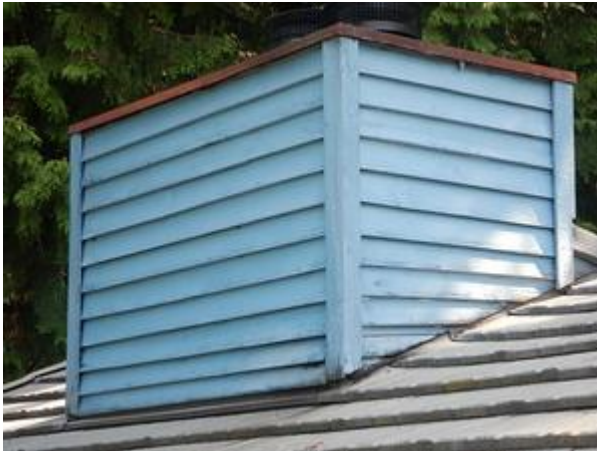
No significant defects were noted in the visible sections of the wood frame chimney chase but the siding is overdue to be repainted. The chimney siding should be properly prepped (cleaned, scraped and primed) and painted as soon as possible.

wood lap siding is overdue to be painted

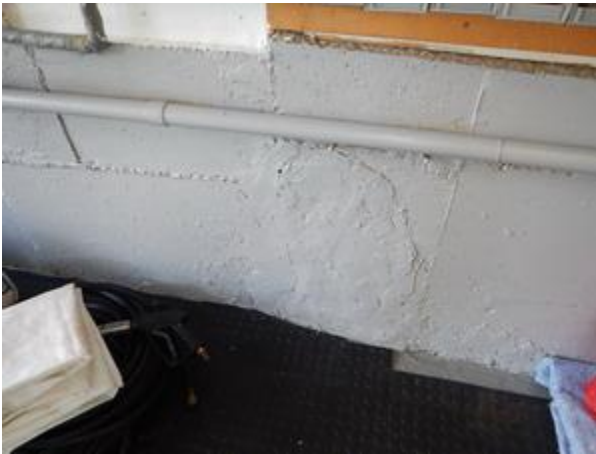
There has been a significant patch or repair to the north garage foundation wall. Although no collateral effects were noted, whatever deficiency was being addressed is no longer visible, so a written dialogue with the seller on this point is recommended.

patch or repair to foundation wall

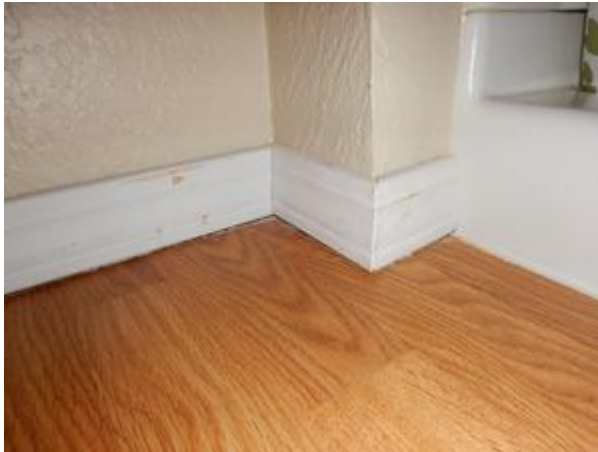
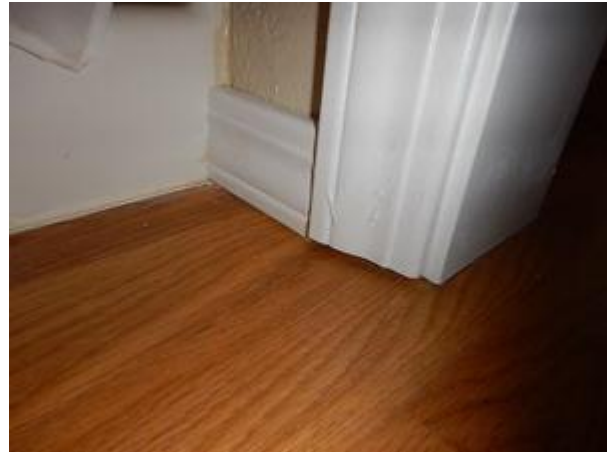
No significant defects were noted in the three-piece fiberglass shower enclosure, fiberglass shower pan, or fixtures. **The transition between the shower pan and the flooring is due to be recaulked; caulking the transitions at the baseboard trim is also recommended.**

shower pan and baseboard trim should be caulked

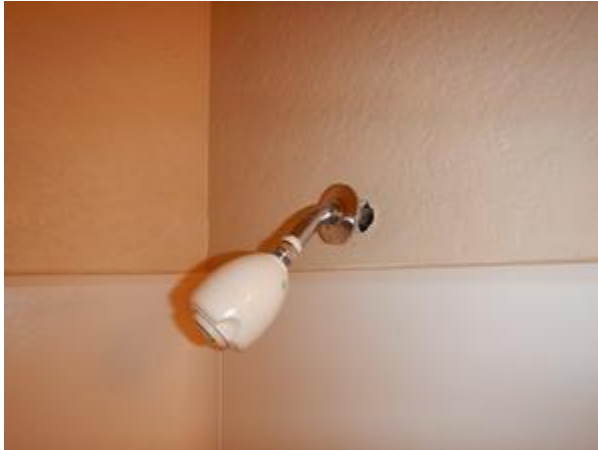
No significant defects were noted in the fiberglass bathtub, three-piece fiberglass shower surround, or fixtures. **The showerhead as it is not well secured in the wall cavity; frequent rapid movement of the fixture may eventually lead to wear and a possible leak in this area. Corrective action by a licensed and qualified plumbing contractor is recommended. The transition between the bathtub and the floor is not caulked and the baseboard trim has not been secured;** the trim should be properly nailed in place and all transitions caulked as necessary to prevent moisture intrusion underneath the flooring.

showerhead is not properly secured

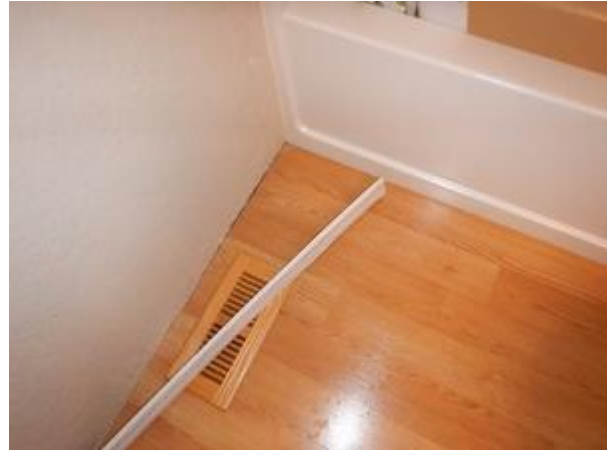
baseboard trim is not secured

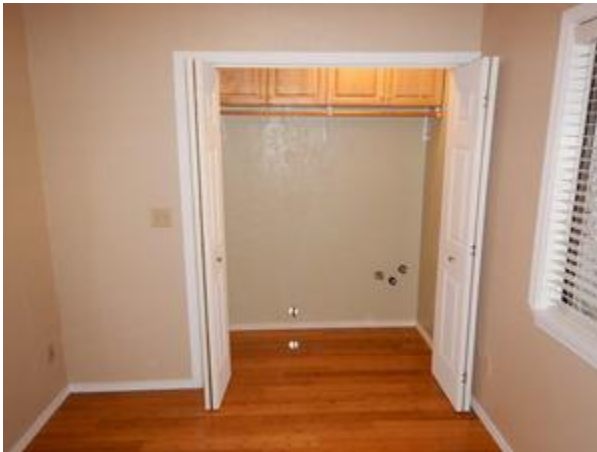
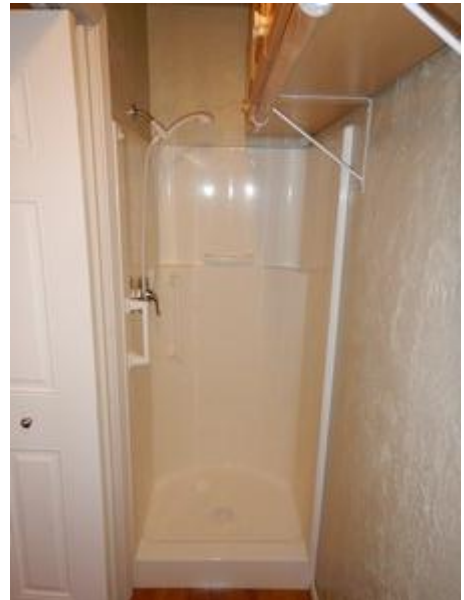
7
8 **It appears that, despite its size, the closet was once converted into a $\frac{3}{4}$ bathroom with**
9 **a shower, commode and sink. The sink and commode have since been removed, but the**
10 **shower is still in place. The drain has been taped over, so the shower was not**
11 **operated/evaluated. It could not be confirmed whether the drain for the commode has been**
12 **properly capped; if not, it may allow methane gas to escape into the living area. A written**
13 **dialogue with the seller on this point and/or complete removal of all plumbing is**
14 **recommended.**
15

16 closet converted into $\frac{3}{4}$ bathroom, shower is still intact
17
18
19

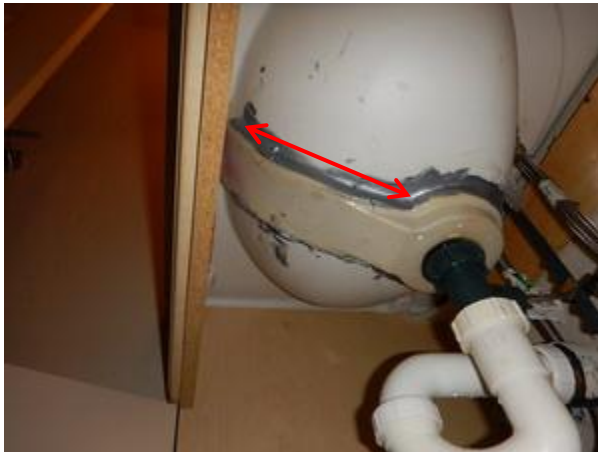
The overflow channel in the one-piece cultured marble sink does not function and leaks copiously; replacement of the sink is recommended.

high volume leak in overflow channel

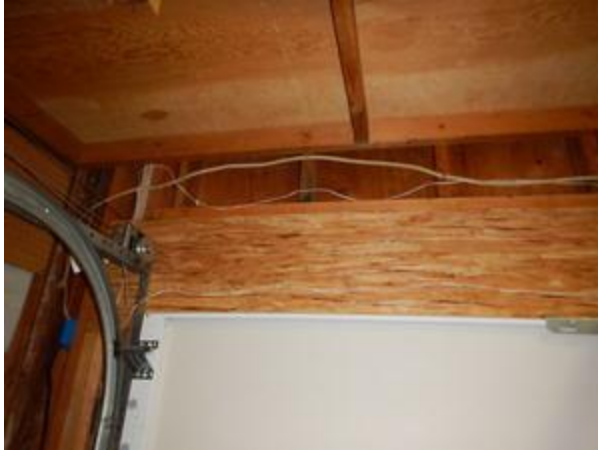
37
38 Some of the walls and all of the concrete slab floor are obstructed with padding
39 and/or stored material and could not be inspected. No voids or penetrations in the walls or
40 ceiling of the fire-rated separation isolating the garage from the rest of the structure were noted.
41 **The existence of the micro-lam header above the garage doors evidences substantial**
42 **structural changes of an undetermined nature; a written dialogue with the seller on this point**
43 **is recommended.**

micro-lam header over garage doors

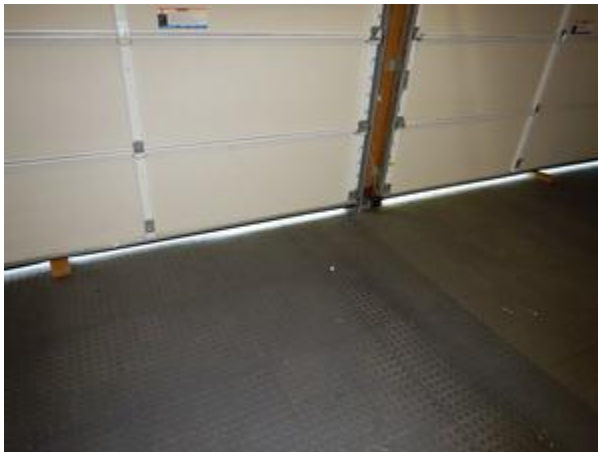
The garage doors are controlled by electric garage door openers. The openers are functional, as is the motion sensor-reversing mechanism on the south door (the north door is not so equipped). **The resistance-activated safety mechanisms are not functional.** The access door to the living area is not equipped with a deadbolt lock; deadbolts are recommended in windowed garages

resistance activated safety stops not functional
