GENERAL BUILDING INSPECTION FOR
1102 205th Avenue NE, Sammamish WA 98074
FOR THE EXCLUSIVE USE OF Matthijs and Sandra Hoekstra

Tuesday, July 14, 2015, 10:00 AM

cover letter, 28 page report

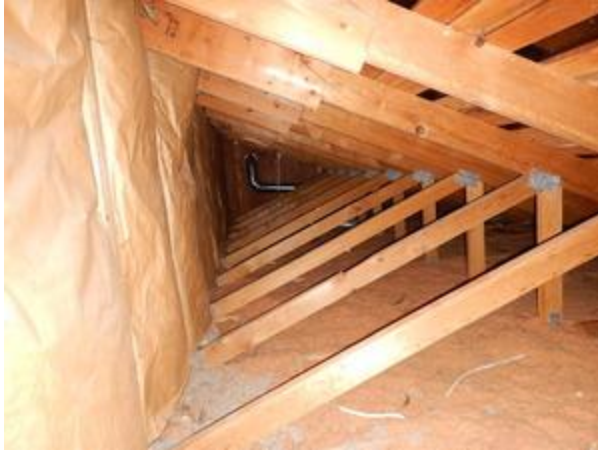
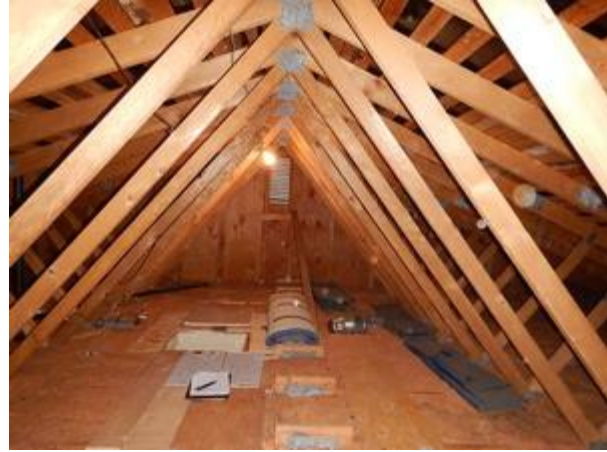
The access to the attic is via a pass-through in the ceiling of the hallway closet. Entry to the attic reveals truss construction of a 2x4 configuration 24 inches on center. The 1x4 skip sheathing appears to be in serviceable condition.

attic/roof framing, typical

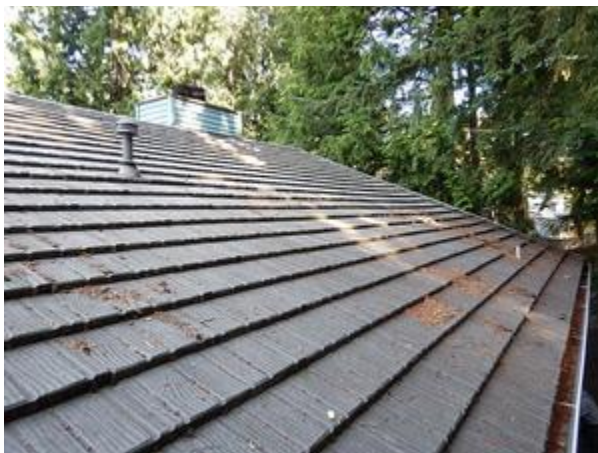
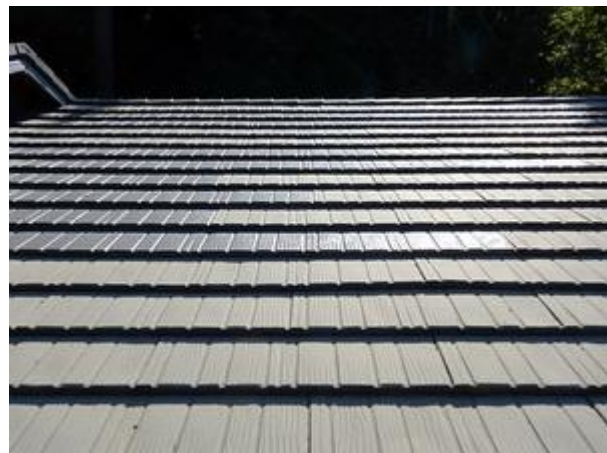
The visible roof consists of one tier of imitation tile metal shingles. Due to the delicate and slippery nature of this type of roofing material, it could not be walked safely. The roof was therefore inspected at random points from a ladder. Although most significant defects will usually be visible, some defects may go undetected when the roof cannot be walked. *There may be deficiencies that would have a negative effect on the value of this home.* No significant defects were noted in the roofing material or vertical plane or chimney flashing*. This type of roofing material is frequently installed over an older roof, typically a cedar shake or shingle roof. The skip sheathing in the roof would be consistent with an original shake or shingle roof, but there is no visible evidence of an older roof. A written dialogue with the seller on this point and collateral warranty issues is recommended. Numerous shingles were noted that have been replaced, and several spare shingles were noted in the attic; a conversation with the seller on this point is recommended.

metal shingle roof, typical

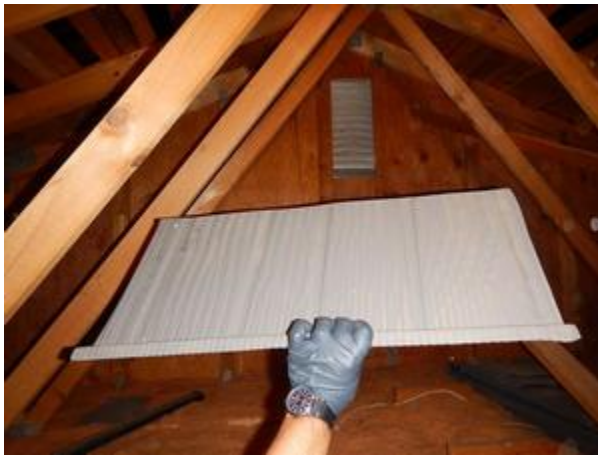
spare shingles in the attic
